## A Survey of Thatched Buildings in Scotland

Thatch Survey of Scotland  
2014-15

A photographic survey of thatched buildings in Scotland, surveyed between May 2014 and August 2015 by Zoe Herbert (SPAB Scotland Officer), on behalf of the Society for the Protection of Ancient Buildings.

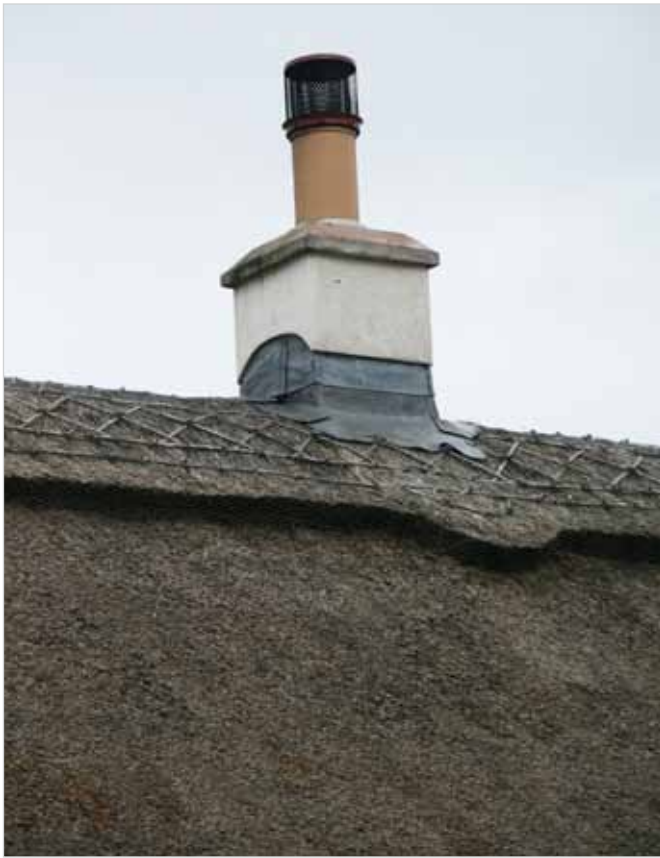
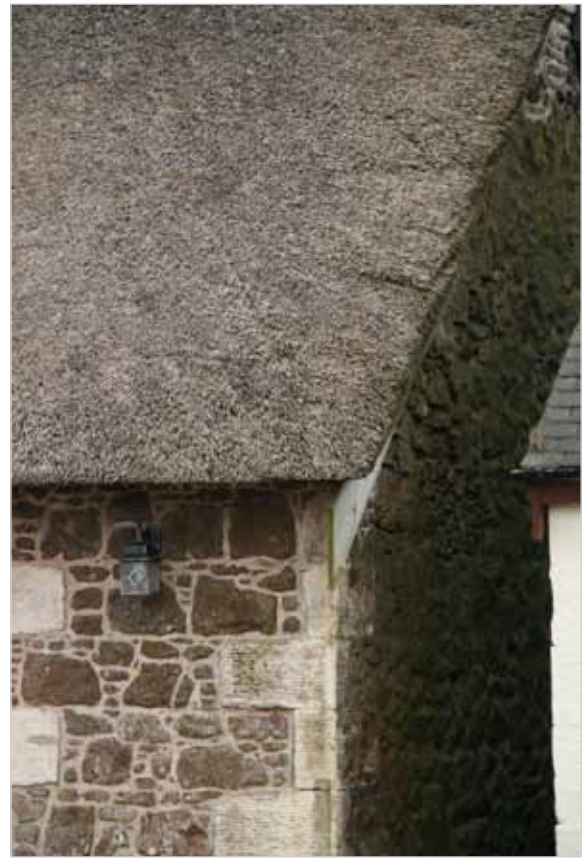
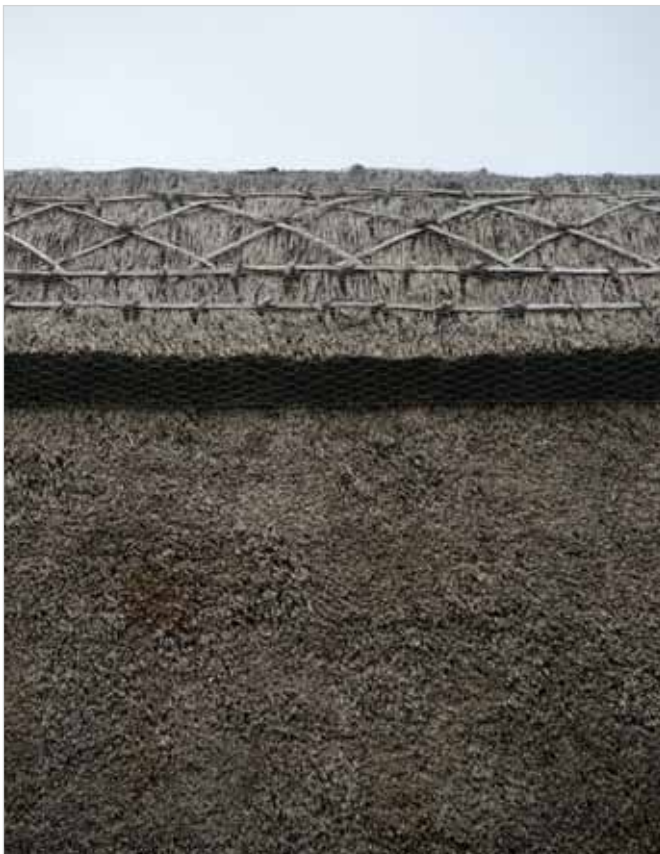
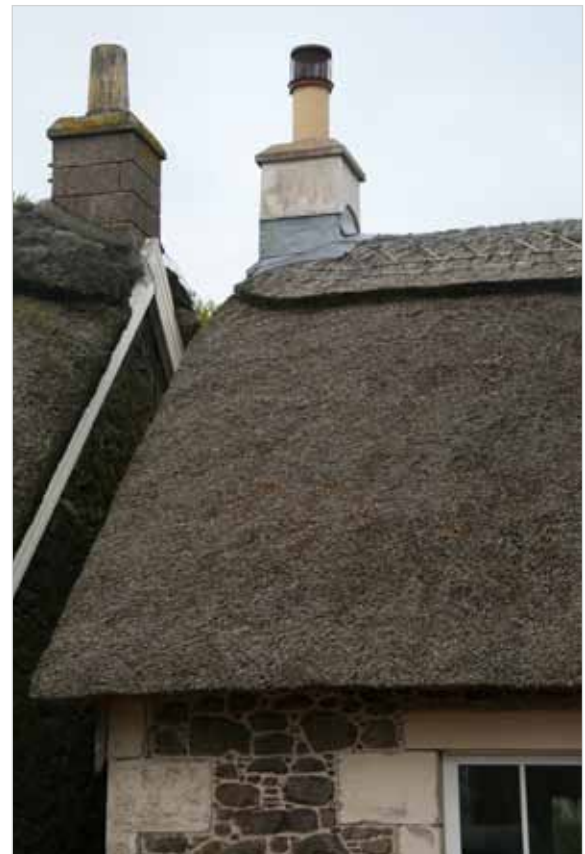
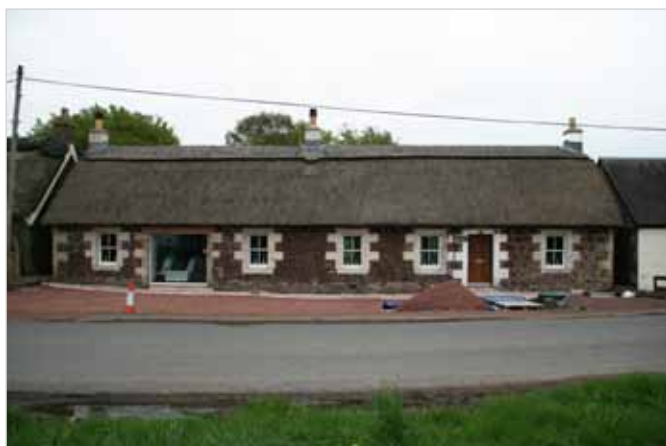
82 Covington Road – South Lanarkshire

Condition of Thatch: ..... Good

spars. The ridge is netted in wire whilst the rest of the thatch is uncovered.

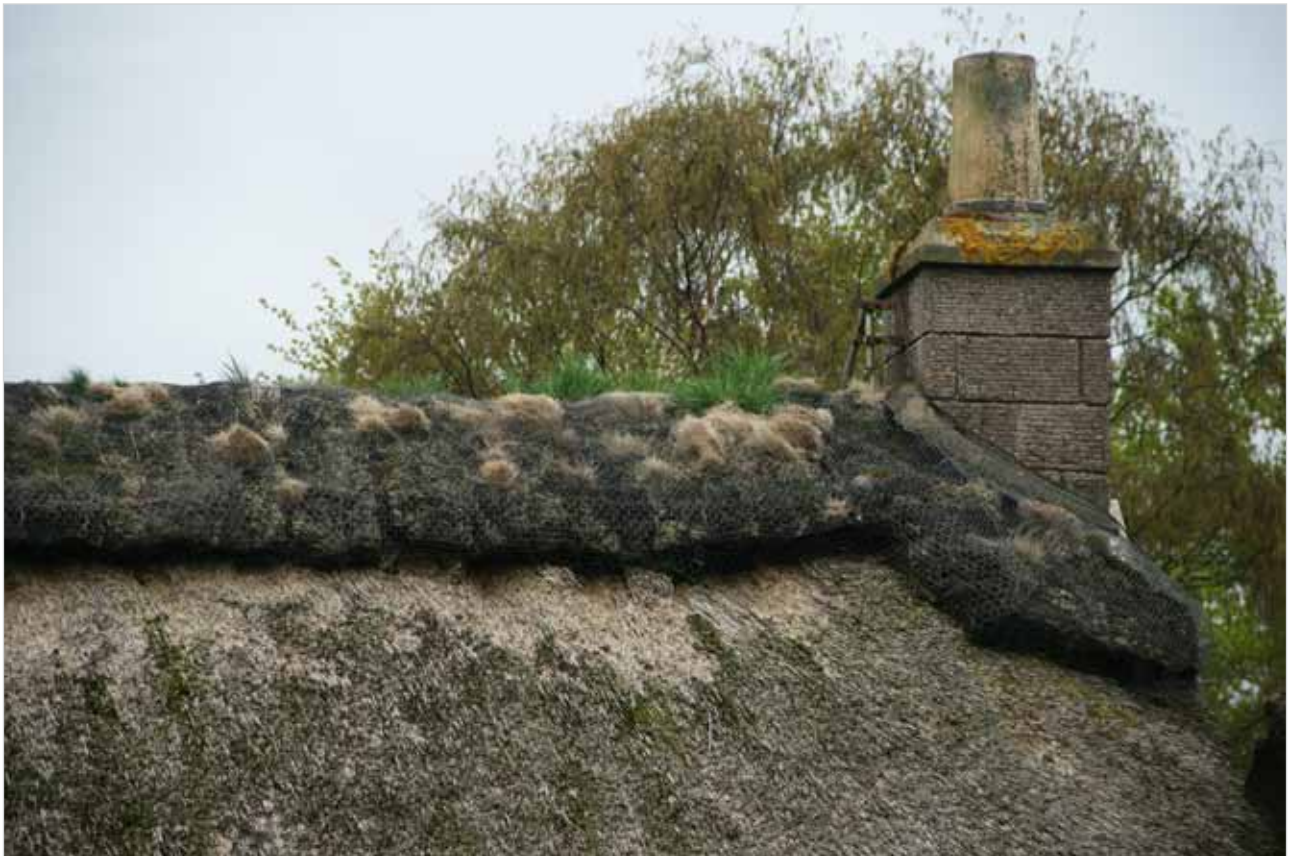
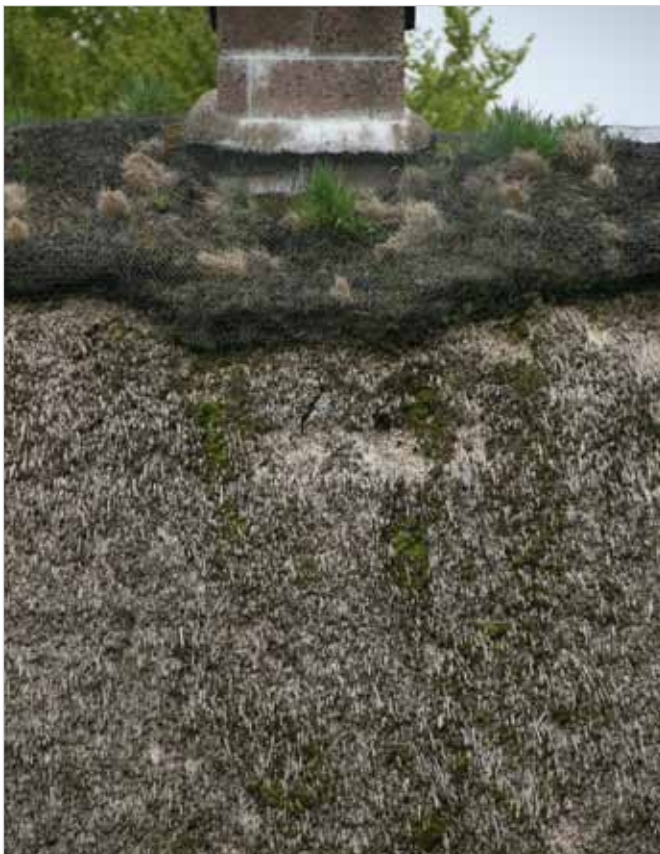
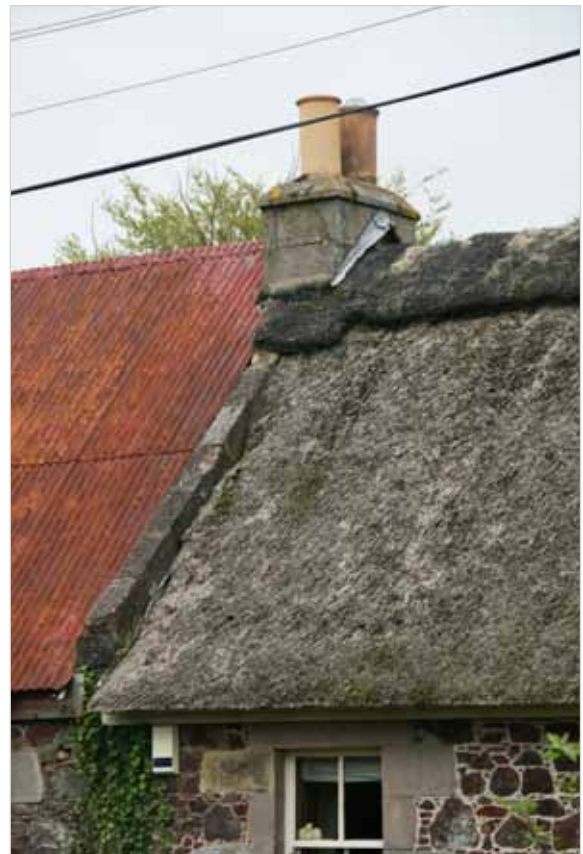
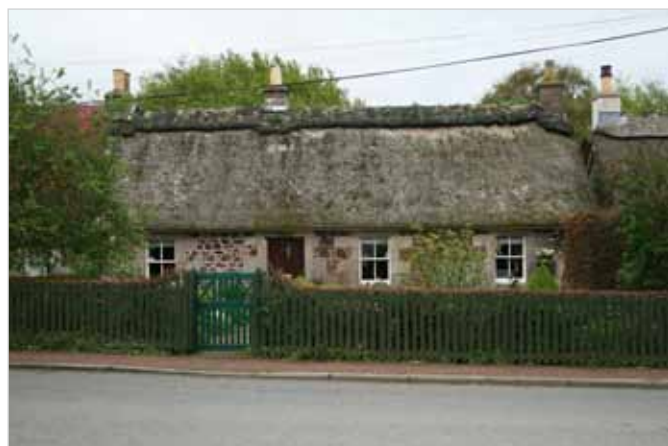
86 Covington Road – South Lanarkshire

Condition of Thatch: ..... Fair

throughout and small patches of missing/sunken thatch in places. The raised thatch ridge is fairly overgrown and it

ridge is netted, whilst the rest of the thatch is left

uncovered.

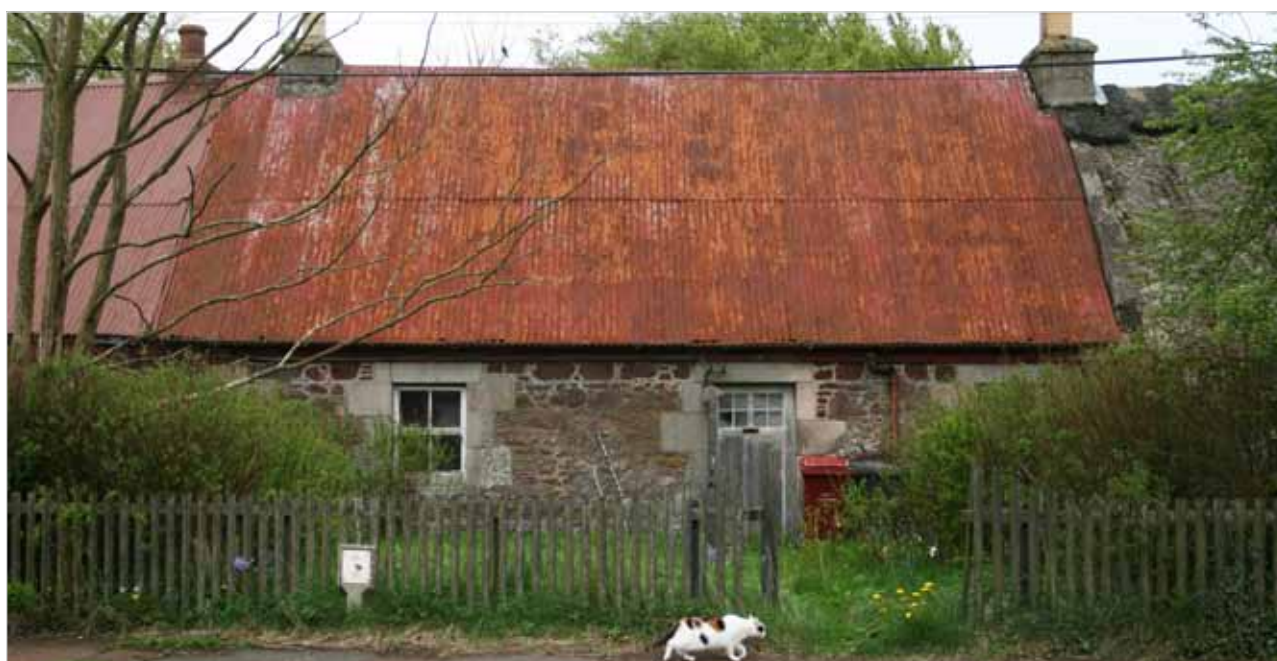
**Additional Notes:** ..... Early 19th-century three-bay cottage, from a group listing, believed to still have thatch underneath the corrugated iron roof. The building has been on the Buildings at Risk (BAR) register since 2014 (BAR reference number 4807). The building is thought to have been vacant for some years and local authorities have been unable to contact the owners. The corrugated iron remains in place (on visible front elevation) but it is in poor condition. Further research into this building is required and the listing description should be updated accordingly.

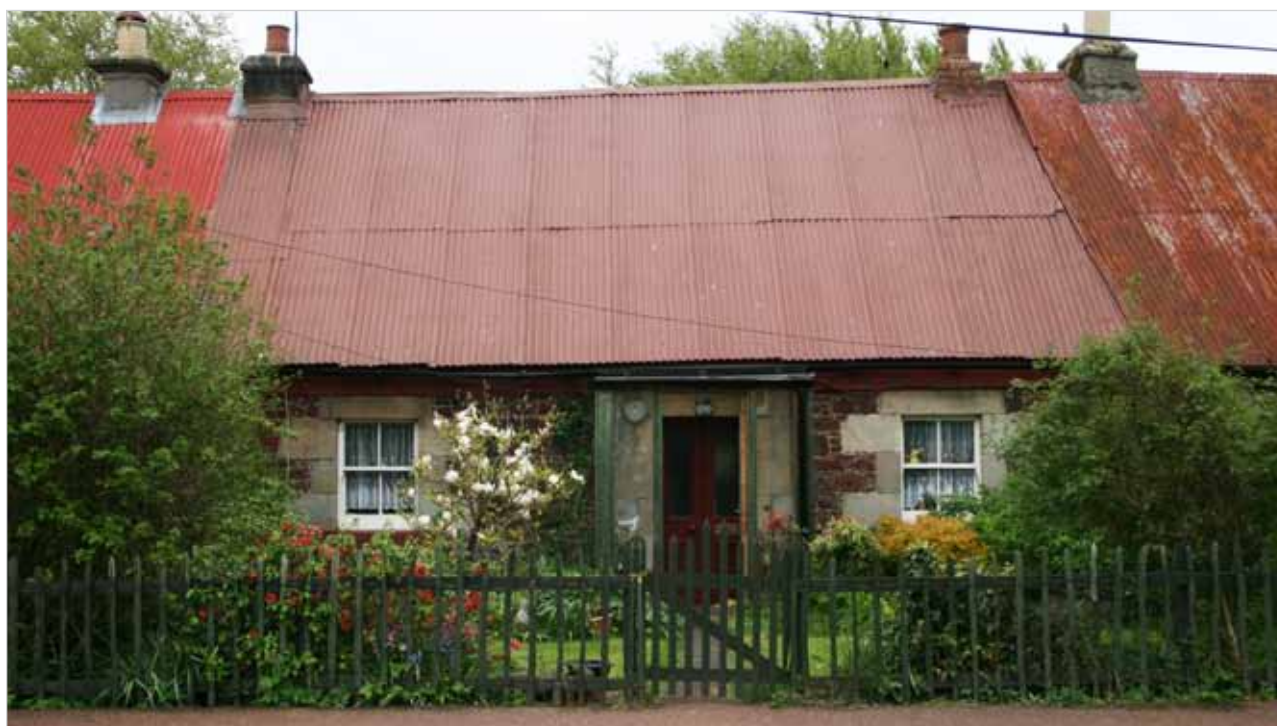
Address: ..... 90 Covington Road

**Additional Notes:** ..... One of seven early 19th-century, single-storey cottages that forms part of a group listing in the village of Covington, South Lanarkshire. All of the cottages in the listing were originally thatched, though there is no mention of any thatch remaining underneath the corrugated iron in the listing description (only number 86 Covington Road is mentioned as being thatched). Further research into this building is required to ascertain whether any thatch remains underneath the corrugated iron roof.

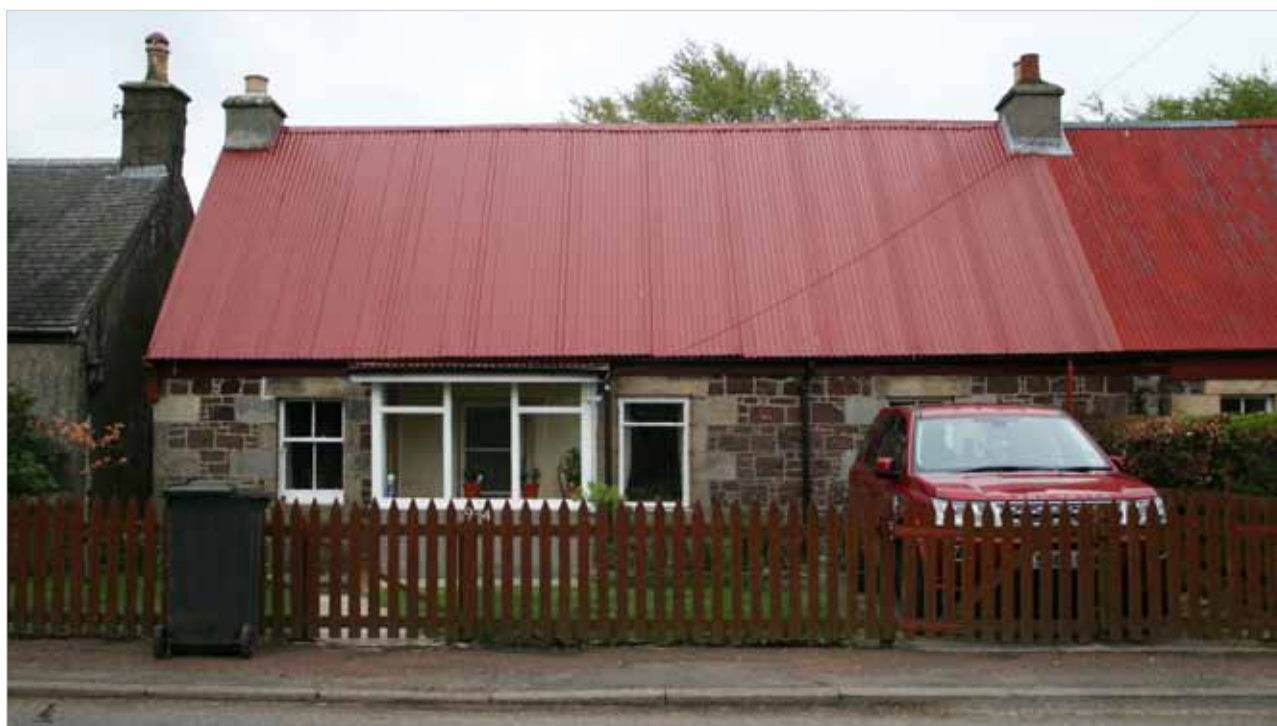
Address: ..... 94 Covington Road

**Additional Notes:** ..... One of seven early 19th-century, single-storey cottages that forms part of a group listing in the village of Covington, South Lanarkshire. All of the cottages in the listing were originally thatched, though there is no mention of any thatch remaining underneath the corrugated iron in the listing description (only number 86 Covington Road is mentioned as being thatched). Further research into this building is required to ascertain whether any thatch remains underneath the corrugated iron roof.

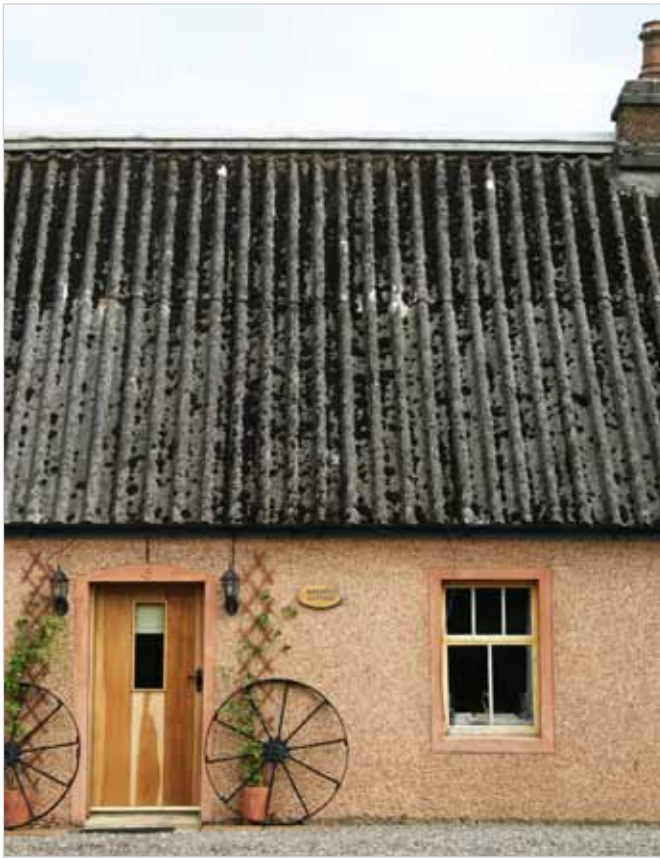
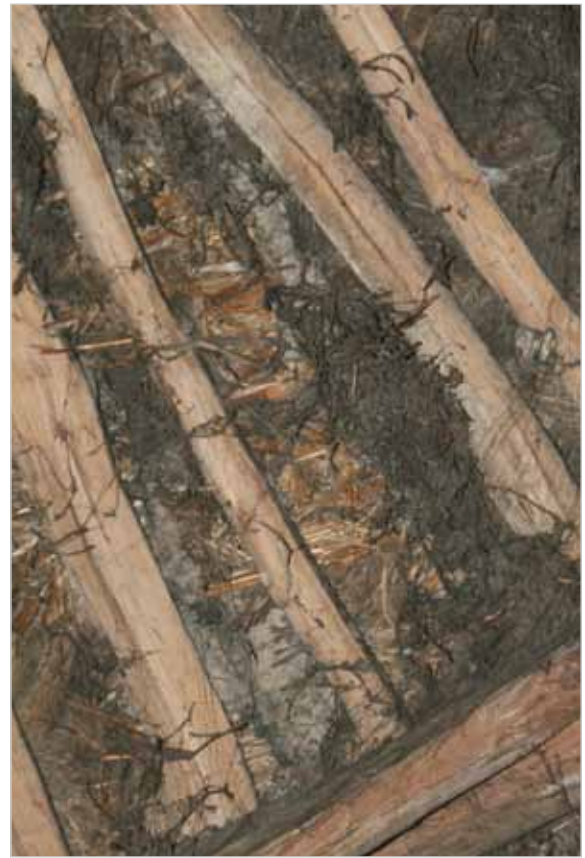
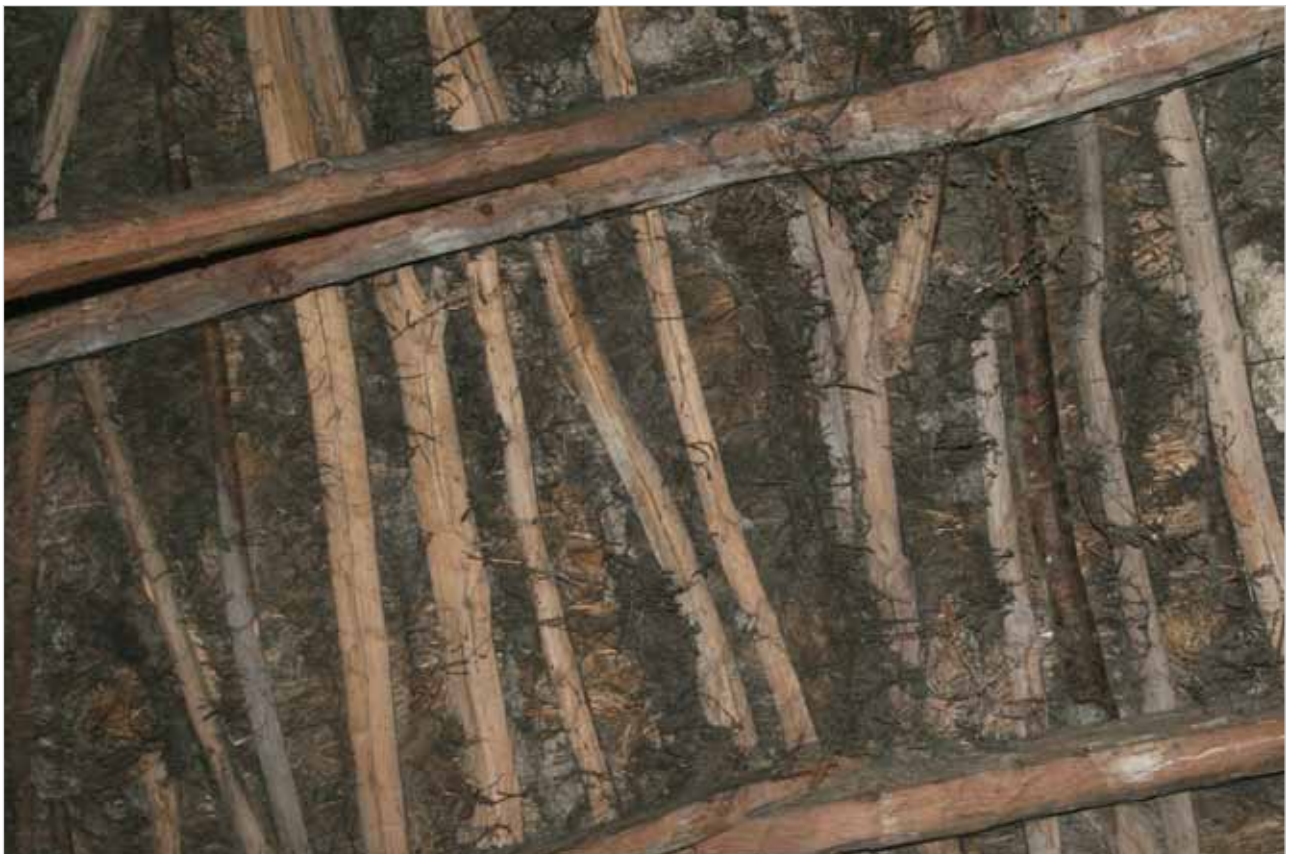
Birkfield Cottage – South Lanarkshire

**Additional Notes:** ..... Single-storey mid/late 18th-century cottage building, retaining original thatch underneath a corrugated asbestos sheeting carried on a raised brick eaves course. The building owner states that the roof has a heather underlay with straw on top, however the notes in the listing description states '*the thatch is probably straw, laid vertically and stitched over turf divots*'. The thatch is visible internally within the roof space, but it is difficult to ascertain the condition. There is no thatch visible externally. The asbestos roof appears in a good condition and looks to be protecting the thatch from the external elements. The building owner had looked into

removing the asbestos roof and re-thatching the building in the past, but this had always been too costly to be viable.

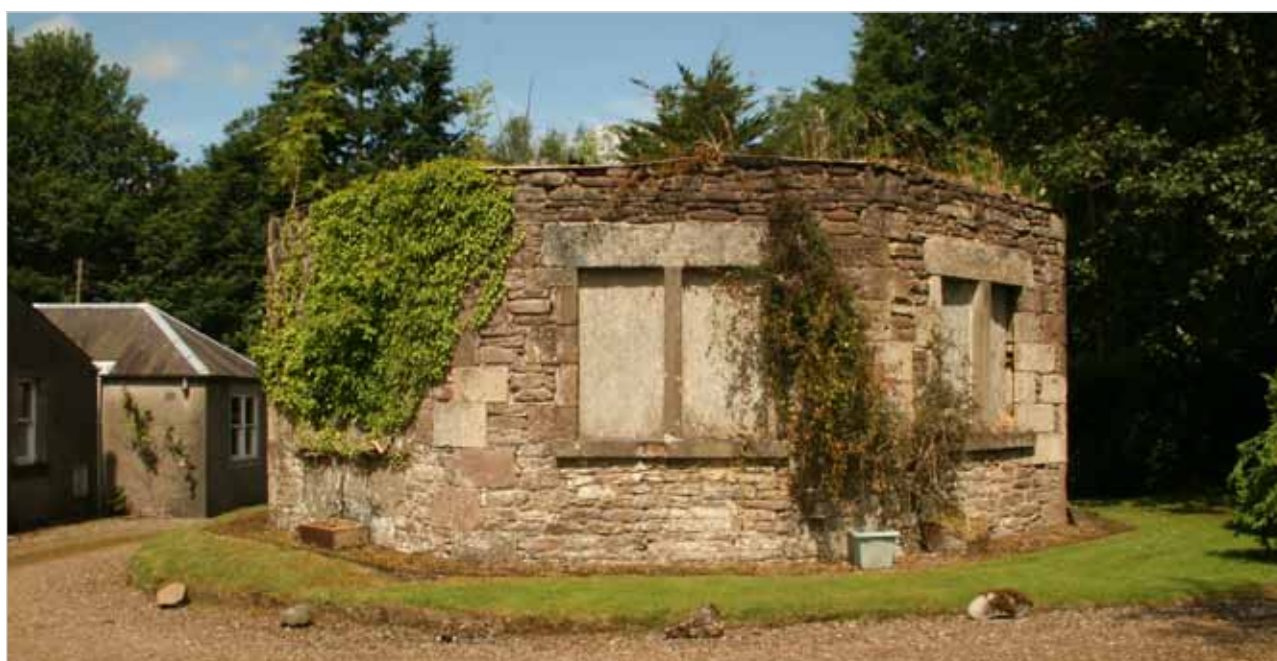
**Additional Notes:** ..... The owner has lived in the adjacent house for around 30 years and stated that when she moved in, the Octagon was dangerous, particularly the roof. At this time, around half of the thatch had already come off and they later removed the chimney, and subsequently the roof, as it was too dangerous. The last of the thatch came off the building at least 20 years ago. The listing description states that the building [had] a 'steep thatched roof' and is circa 1900. The structure is now a roofless ruin. The listing description for the building should be updated accordingly.

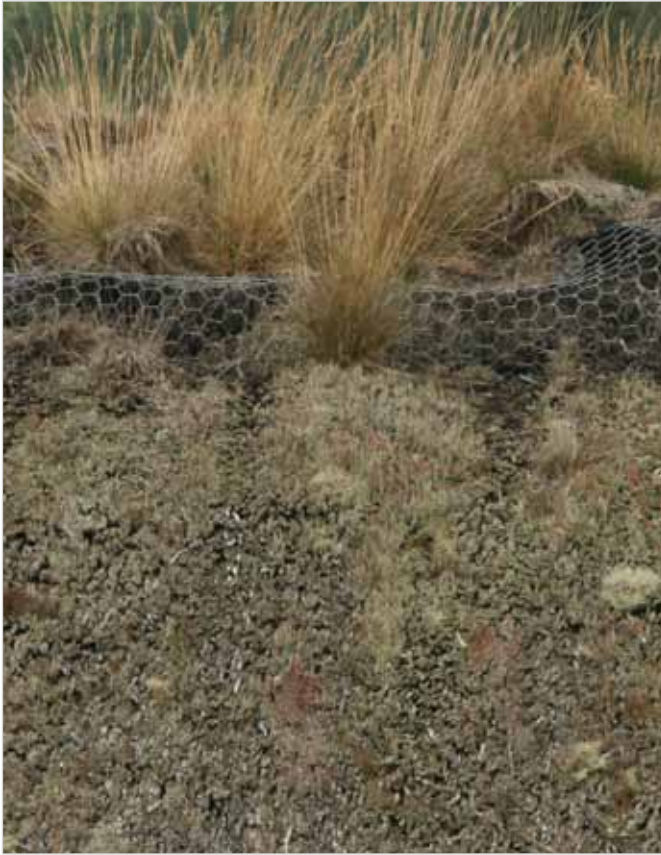
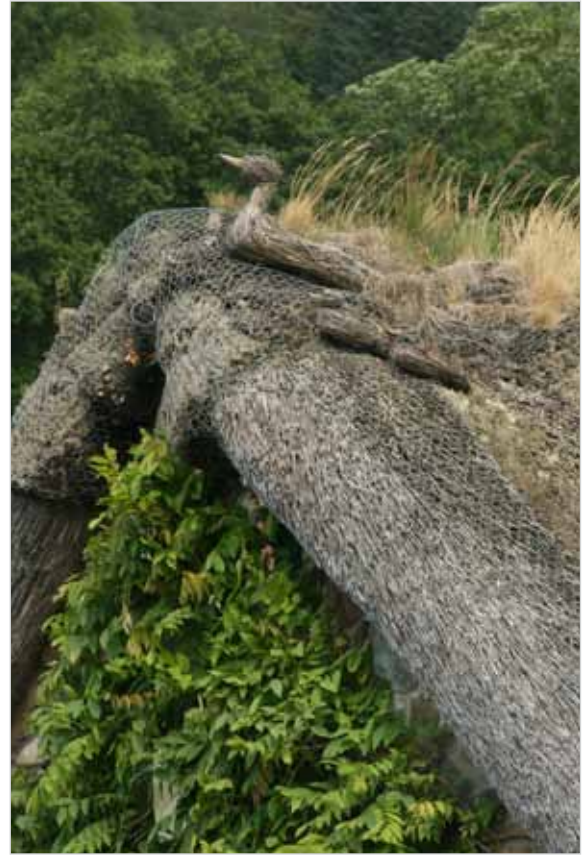
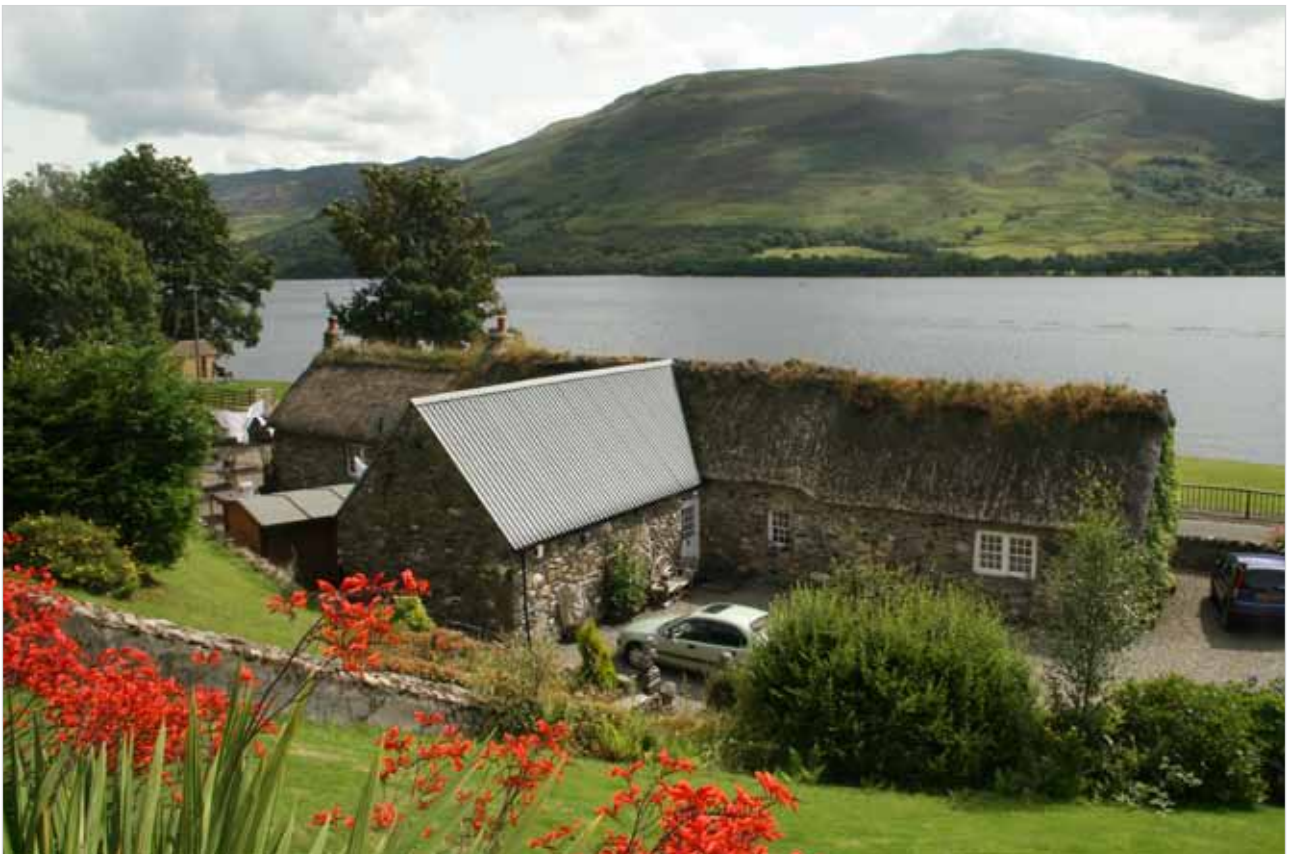
Briar Cottage – Stirling

Thatch Type: ..... Reed  
Ridge Type: ..... Thatched (Turf)  
Condition: ..... Good

**Additional Notes:** ..... Late 18th to early 19th-century cottage, originally two single-storey cottages (the cruck-framed cottage to the east and the slightly taller cottage to the west), currently used as a holiday let. The current owner bought the property in 2008, at which time the west cottage was thatched in Tay reed and the east cottage was thatched in heather. After being in the building for around a year the owner decided that the heather roof was too cold to be habitable and the decision was made to re-thatch this section of the building in reed. The owner stated that the complete re-thatch of the previously heather section of the roof was completed in 2009. At this time, the ridge of the whole building was also re-thatched in turf. The owner also stated that they dug some turf from land behind the cottage for part of the ridge. The turf ridge is currently netted and is flourishing, and includes some patches of heather. The reed is netted only down the sides at either gable end. The listing description states that the east cottage was thatched in heather, and the west cottage was thatched in marsh reed with a heather ridge, which was how it was thatched prior to 2009. The building was renovated from derelict between 1997-2000 by Findlay McKinnell Associates, at which time a rear extension was added to the north of the building and roofed in corrugated iron. A photograph currently displayed inside Briar Cottage shows the building in 1997 with a corrugated iron roof, but whether any thatch remained underneath this at

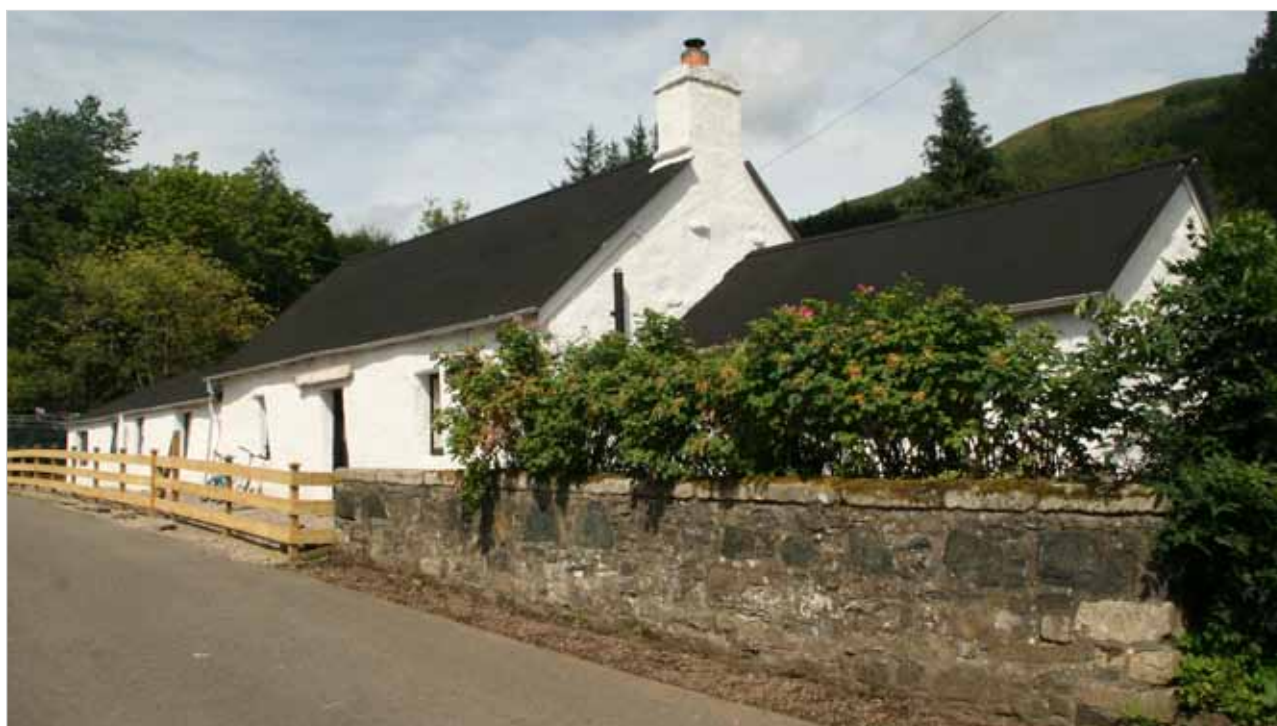
**Additional Notes:** ..... Single-storey, cruck-framed cottage, probably late 18th-century in origin, with later lower extensions adjoining each gable end. The listing description states it has '*heather thatch under turf under [a] corrugated iron roof*'; however, there appears to be no thatch remaining (the owner confirmed there is no visible sign of any thatch externally or internally). The location of the building according to Canmore was incorrect and needs updating, and the listing description should also be updated accordingly.

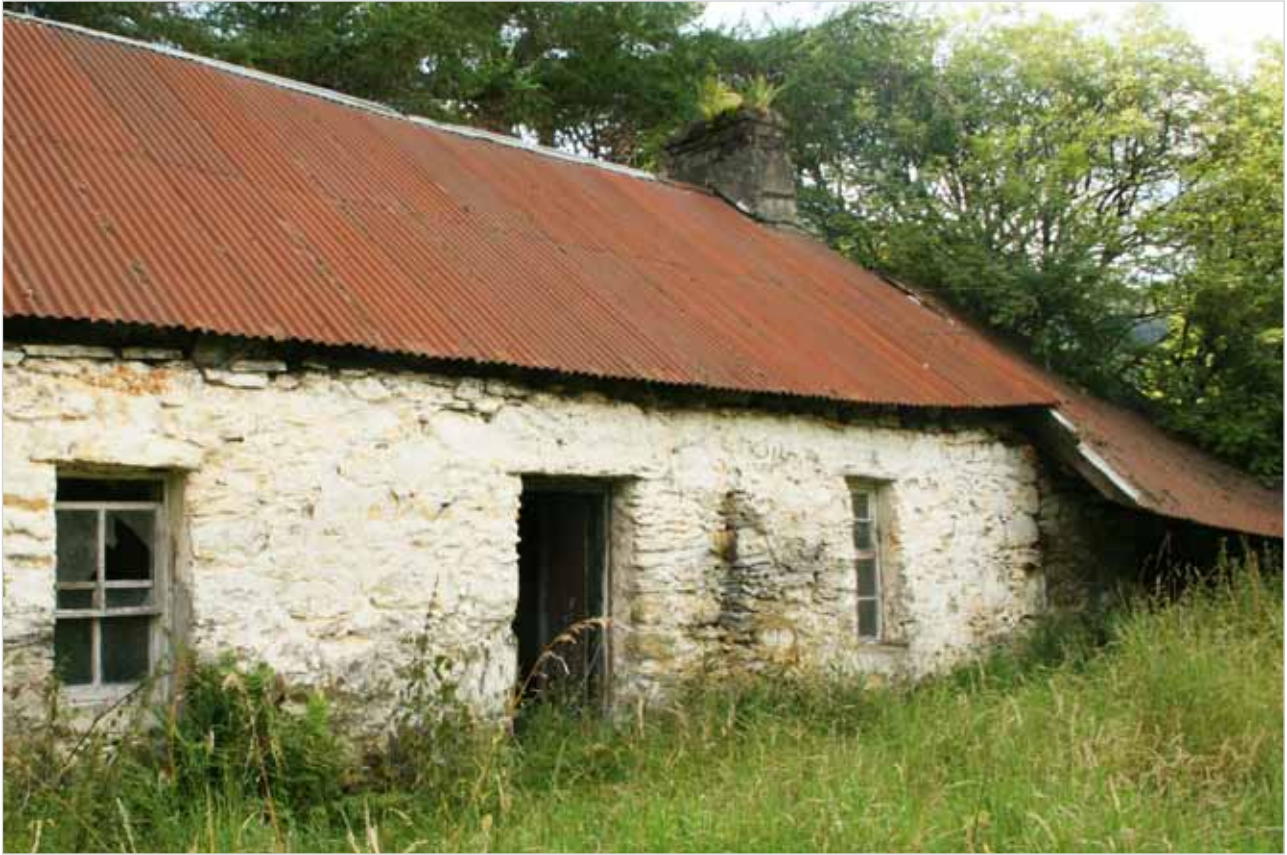
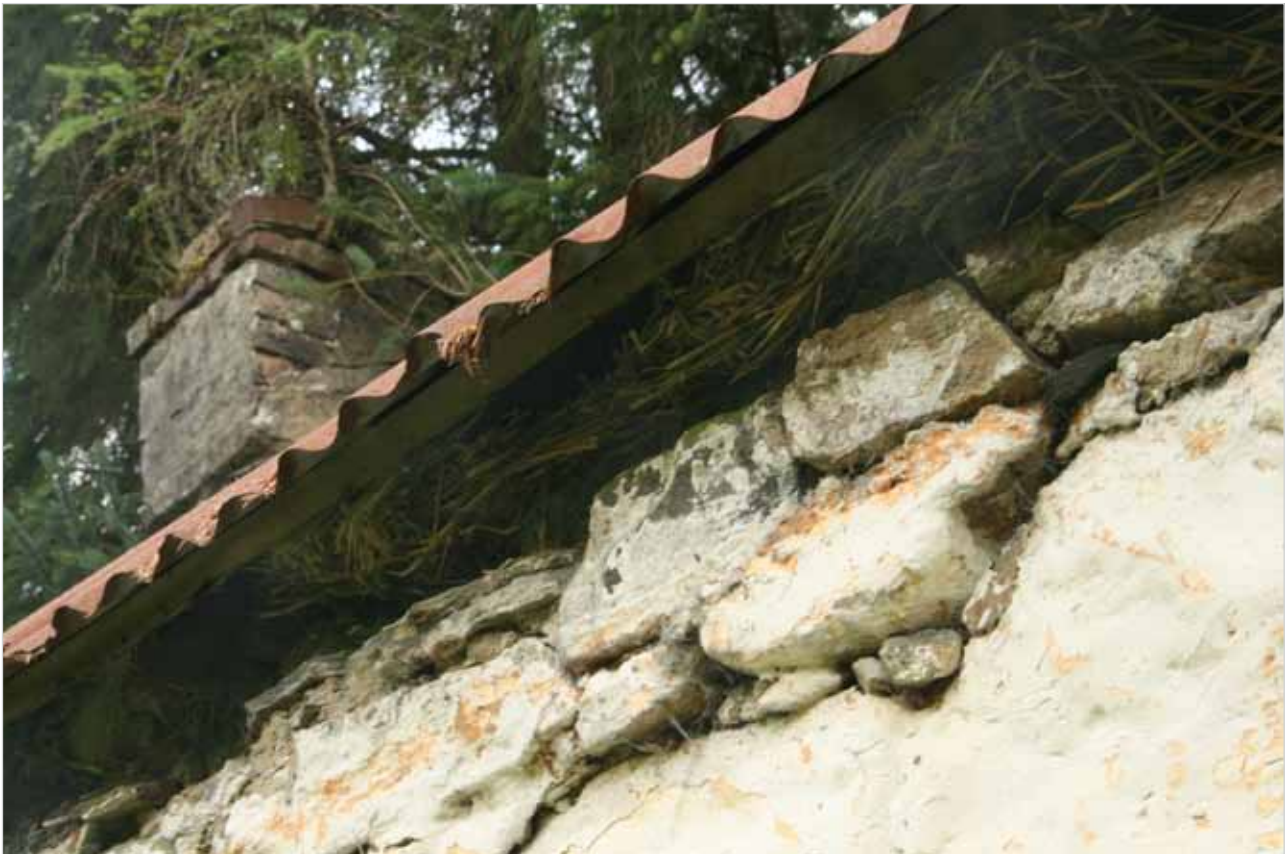
Jock's Croft – Stirling

number 966) at which time it was '*in a very dilapidated state*'. Since then the building and thatch has deteriorated

further. It was last visited by BAR in 2012 when it was noted the '*building [is] subject to slow general decay*'. Due

to the buildings' condition, it is unclear what the current condition of the thatch is, though there are signs of straw

visible externally from underneath the corrugated

iron roof at the eaves.

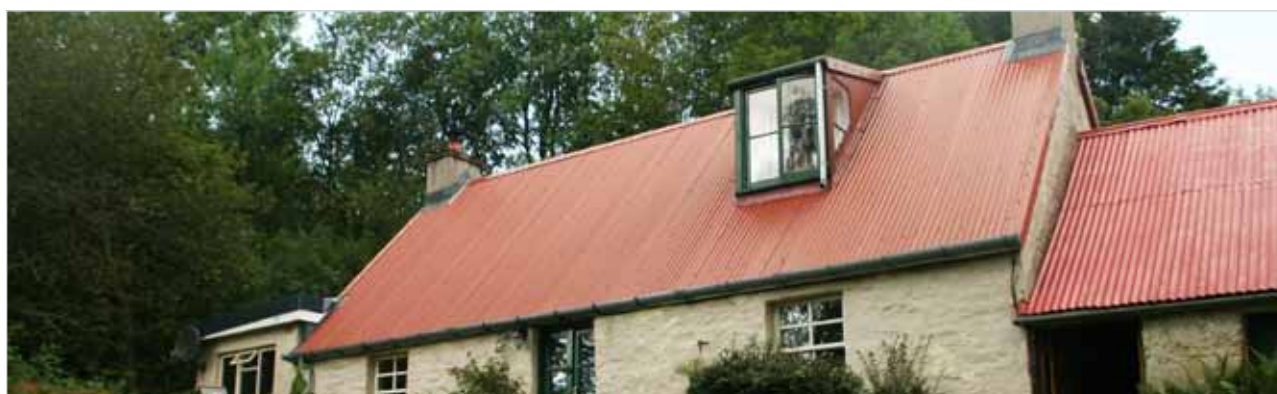
**Additional Notes:** ..... Single-storey, three-bay, cottage with a corrugated iron roof. It has later byre additions to the north-east end. The cottage is thought to have been built during the early 19th century and the listing description states that it retains straw thatch underneath its corrugated iron roof, but the building owner stated that, due to damage obtained from a large tree falling onto the roof from the north five years ago (2009), very little thatch now remains. When the contractors came to fix the roof they discovered the thatch was extremely damp due to previous leaking from the corrugated iron. Many of the beams had also become rotten due to the damp thatch being sat upon them, and so the majority of the thatch which was damaged was removed and the rotten roof beams were replaced. The new corrugated iron roof is in good condition and appears to be sufficiently protecting any remaining thatch underneath, though this cannot be said for certain and the owner does not know for sure how much thatch remains.

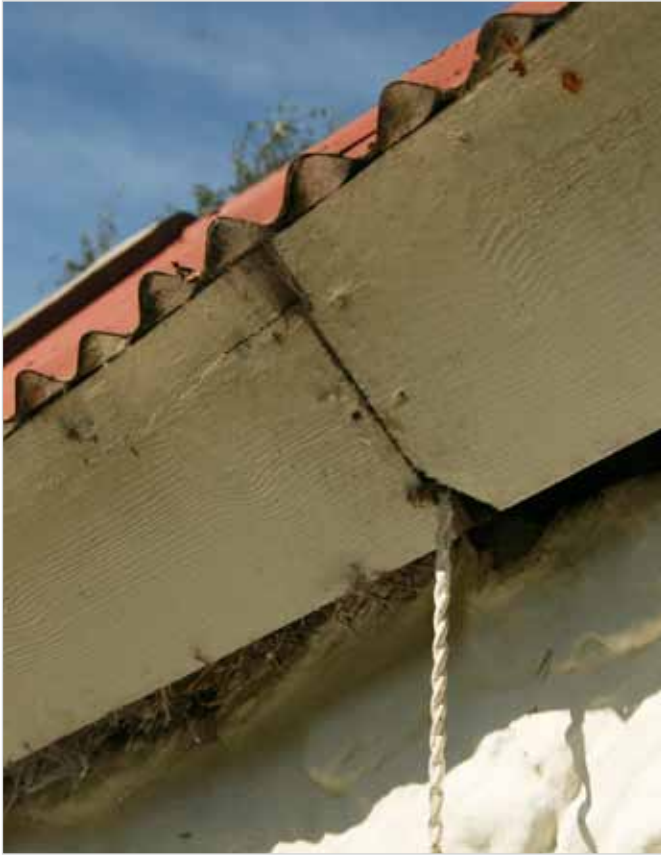
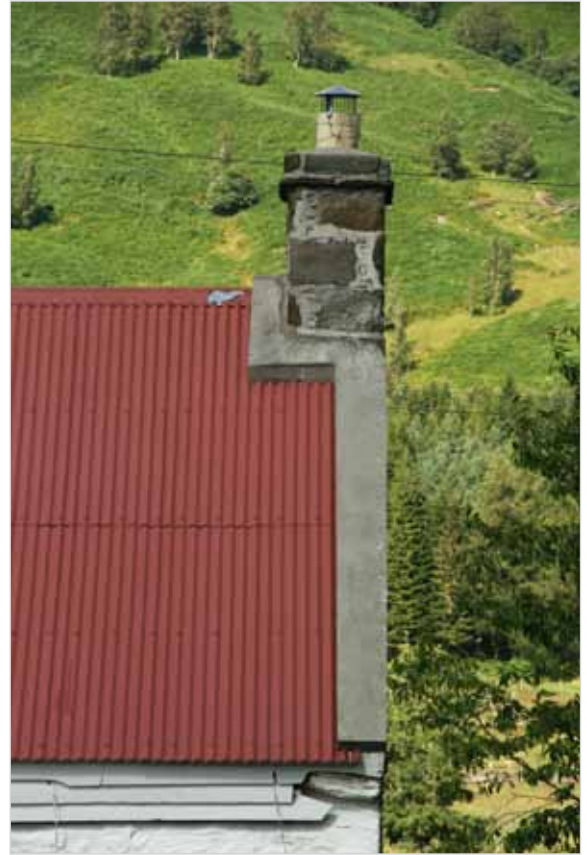
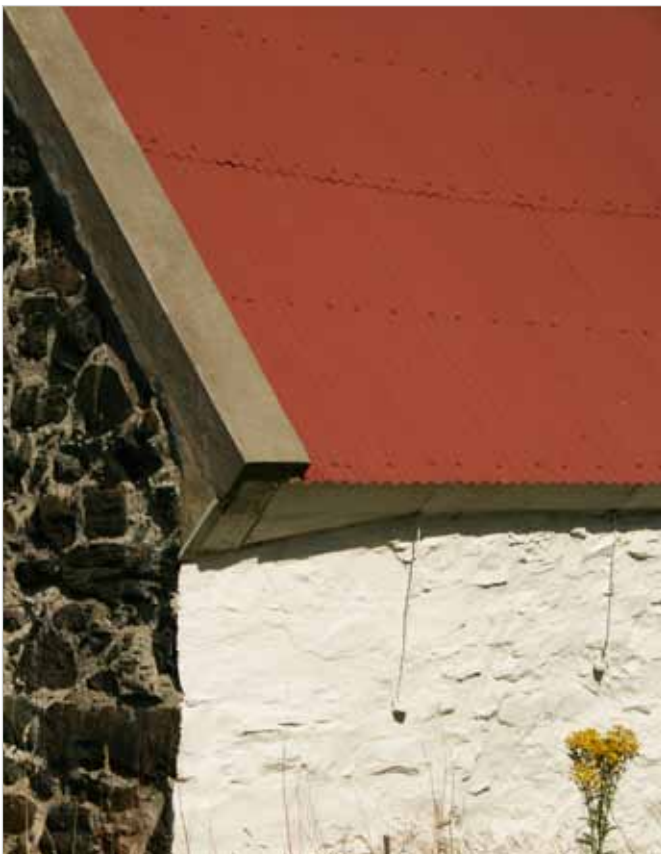
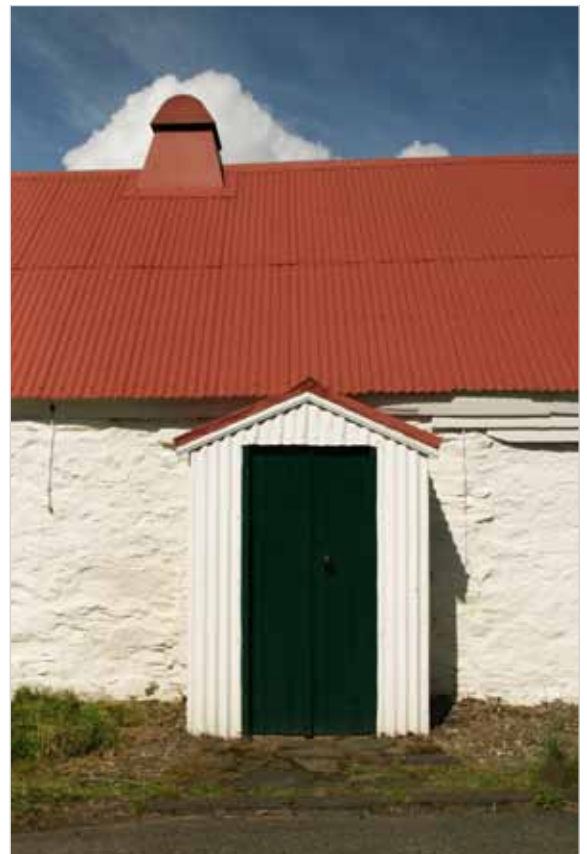
Moirlanich Longhouse – Stirling

**Additional Notes:** ..... Listed as a late 18th to early 19th-century 'cruck-framed cottage and byre under continuous roofline', owned by the National Trust for Scotland since 1992. The building retains early thatch, which was raked back in the 1940s and covered with a corrugated iron roof. There is visible evidence externally of both straw and bracken thatch from underneath the wooden soffit that runs along the eaves of the building. The roof of this building was the subject of an archaeological investigation in 2011, when the corrugated iron roof was temporarily removed (*Moirlanich Longhouse, Killin - Assessment of the Thatched Roof for the National Trust for*

*Scotland'*, Holden, 2011). The report reveals areas of bracken, rush, rye straw, wheat straw and cereal straw thatch, which cover a substratum of turf laid vegetation side down. Turf is also used as a packing material at the skews. The presence of wooden pegs throughout suggests the thatch was fixed to the roof using a 'crook and caber' technique.

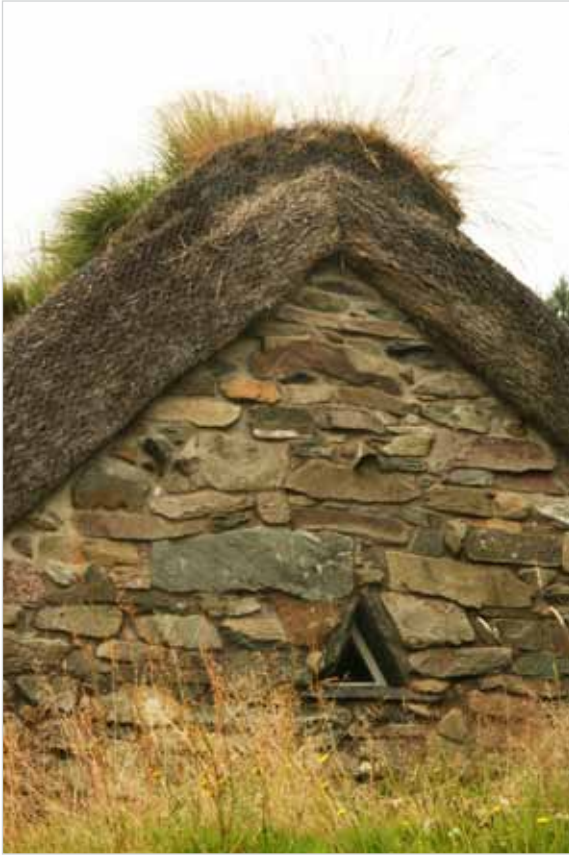
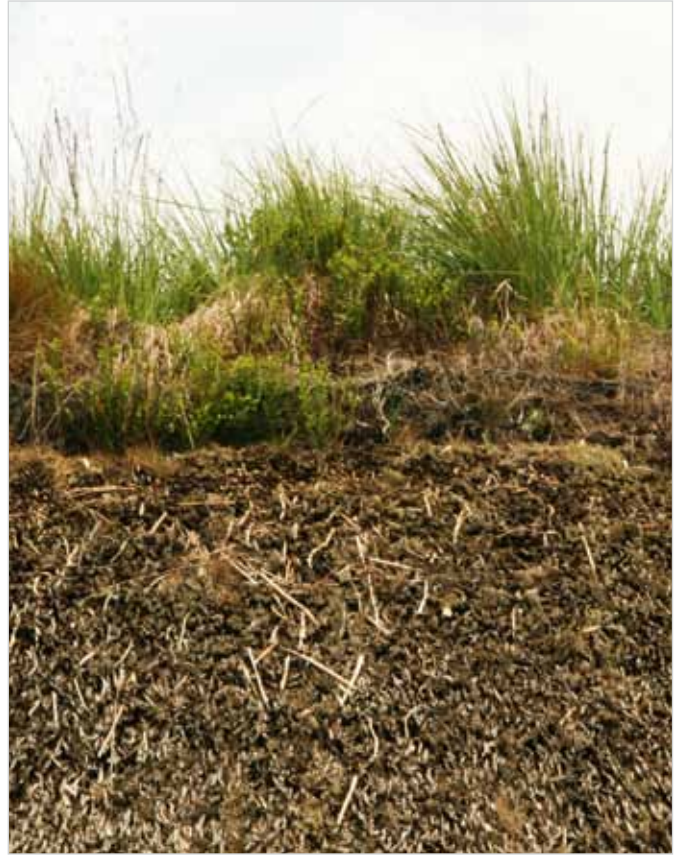
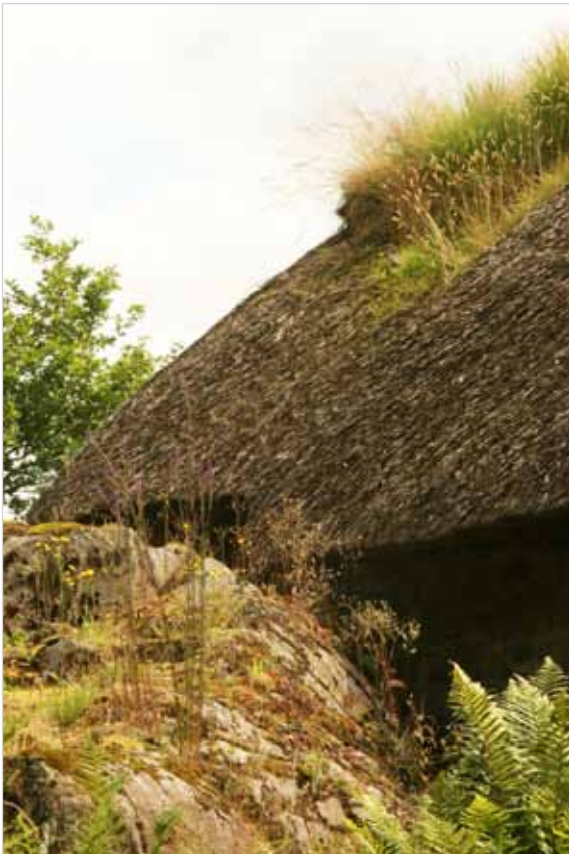
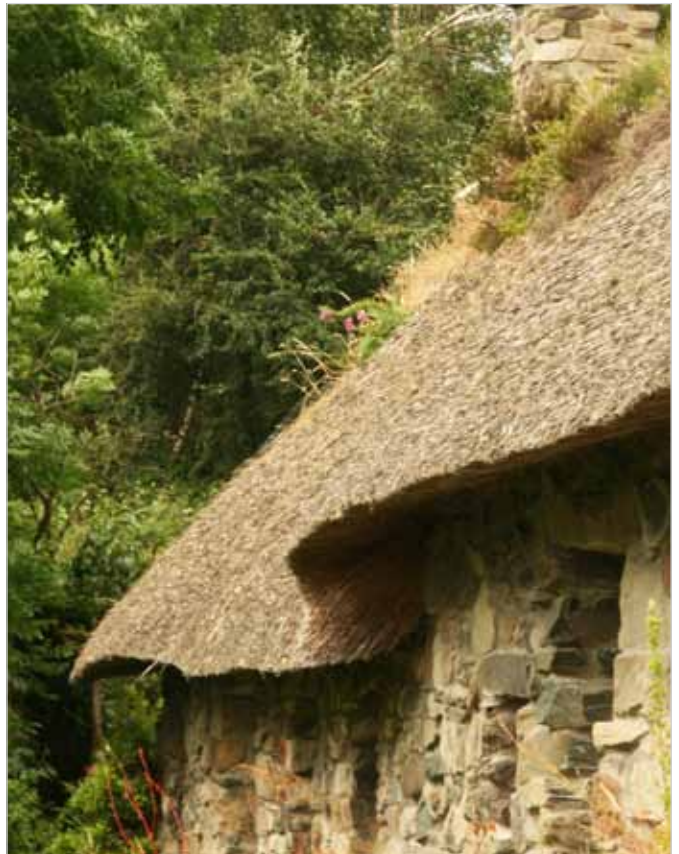
Jean McAlpine's Inn – Stirling

uncovered. The ridge is flourishing and includes a number of different types of grass and heather. The thatch appears to be a reed and is generally in a good condition, with only a few loose pieces of reed in places. The building has a single chimney stack located along the ridge at the west end.
